Operational Management of Grid Transformers – An Experience of POWERGRID

P.N. Dixit, GM; S. Victor, AGM; V.K. Bhaskar, CM; Gunjan Agrawal, Manager
Operation Services Department
Power Grid Corporation of India Ltd.
victor@powergridindia.com

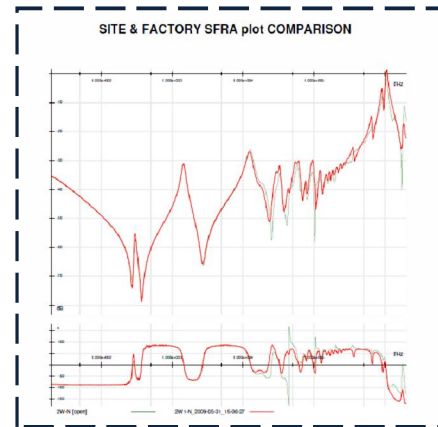
Figure-2- SFRA Signature Comparison

Horizontal X- direction = 2.3 g
 Horizontal Y- direction = 3.1 g
 Vertical Z- direction = 7.7 g

Normally when the equipment is received at site with such recordings, we insist thorough internal inspection and careful comparison of SFRA test results with that of the factory one. In this case the site and factory SFRA signatures were compared and it has shown variation in mid frequency range indicating problem in the winding as shown in graph:

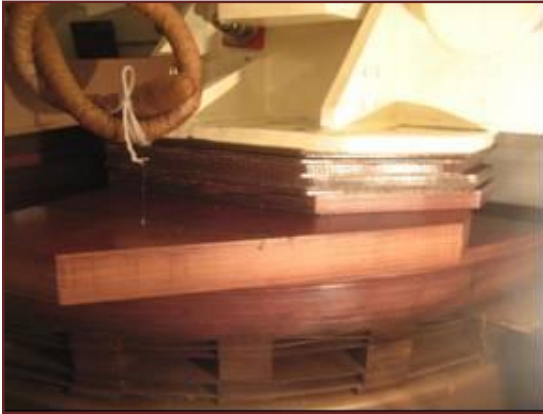
Figure-3- Slip of Support Blocks

transformer. Internal inspection revealed shifting of supporting blocks below top yoke above the coil clamping support ring as shown in the photograph below:

As rectification requires lifting of core coil assembly and also requires complete analysis of the winding, the transformer was sent back to works for repair.

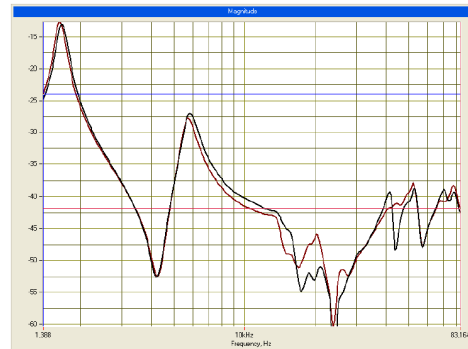
Figure-4 Graph-2: FRA scan of R Phase HV to IV winding

Suspecting the Short circuit performance of the Transformer, a set of SFRA scans were performed on the Transformer. The response was superimposed on pre-commissioning results to see if SFRA test show any abnormality. SFRA results did indeed clearly show that the R-phase Transformer winding has moved.

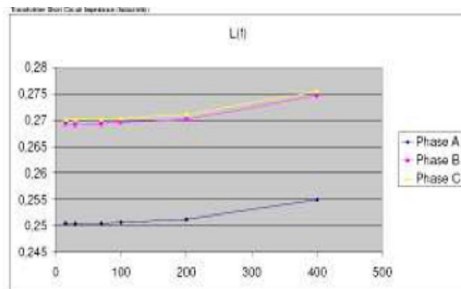
Figure 5: Short circuit Inductance plot of FRSL measurement of Common winding

- Change in the REACTANCE of Common winding (IV-N) of Autotransformer is very significant in R Phase, which is almost 10 % when compared to other two phases as indicated in Graph 4.
- Change in the REACTANCE of Full HV winding (HV-N) of Autotransformer is also significant in Phase A, which is almost 5 % when compared to other two phases.

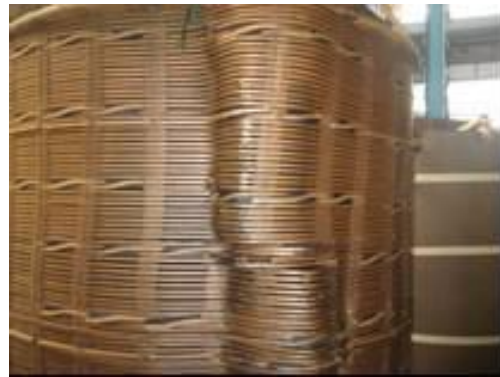
Figure-6 Damaged winding of Transformer

After carrying out all these tests, it was recommended by the manufacturer to charge the Transformer with increased DGA monitoring (fortnightly basis). The Transformer again tripped after five days on differential protection while feeding fault current in 220 kV systems. The transformer was taken out of service and sent to manufacturer's works for detailed investigation. R phase IV winding (220kV) found badly deformed as shown in the figure below:

The transformer was repaired at manufacturer's works by replacing all the coils in R phase. The transformer is operating satisfactorily.

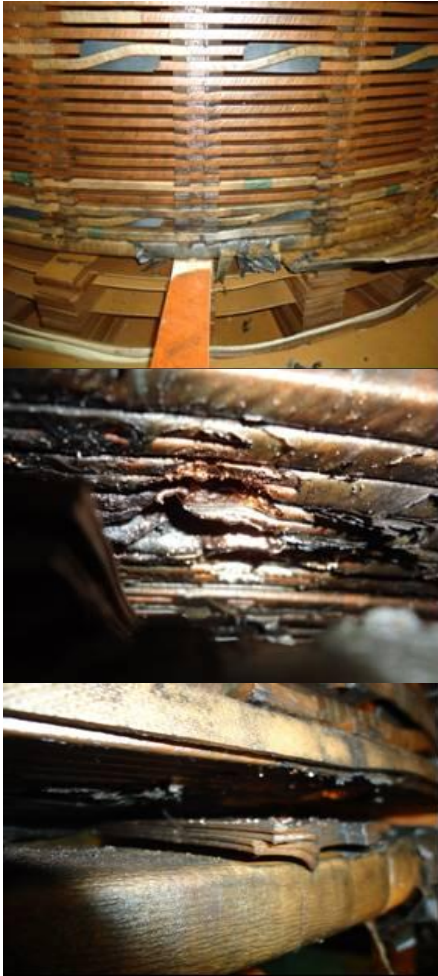
Figure-7 Failure of Winding

As internal inspection could not reveal any other abnormality, it was decided by the manufacturer to take back the transformer to their works for detailed investigation and rectification. During investigation it was found that in IV winding, out of 8 conductors, the extreme conductor was open. The fault was located at the bottom and probably due to manufacturing defect. As the burning was inside and there was no oil circulation in that spot, DGA has not indicated appreciable increase in fault

Copper globules were found and burning marks also noticed on conductors of first disc from bottom and two bays towards the left of IV bottom lead. Flash over mark was also observed on bottom SER (Static End Ring).
