Operational Management of Grid Transformers – An Experience of POWERGRID

P.N. Dixit, GM; S. Victor, AGM; V.K. Bhaskar, CM; Gunjan Agrawal, Manager
Operation Services Department
Power Grid Corporation of India Ltd.
victor@powergridindia.com

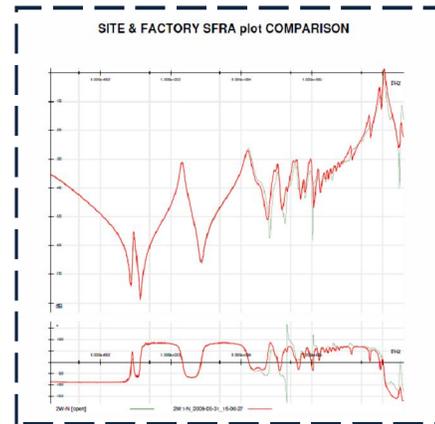
Figure-2- SFRA Signature Comparison

Normally when the equipment is received at site with such recordings, we insist thorough internal inspection and careful comparison of SFRA test results with that of the factory one. In this case the site and factory SFRA signatures were compared and it has shown variation in mid frequency range indicating problem in the winding as shown in graph:

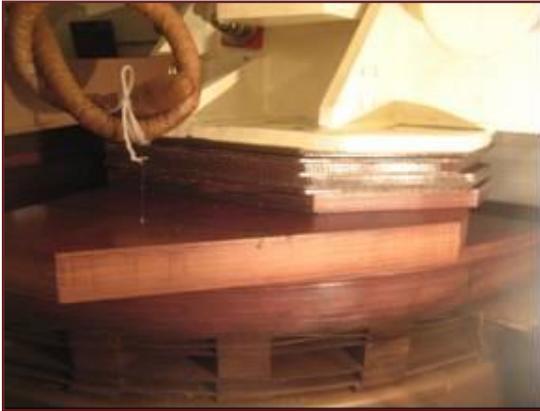
Figure-3- Slip of Support Blocks

transformer. Internal inspection revealed shifting of supporting blocks below top yoke above the coil clamping support ring as shown in the photograph below:

As rectification requires lifting of core coil assembly and also requires complete analysis of the winding, the transformer was sent back to works for repair.

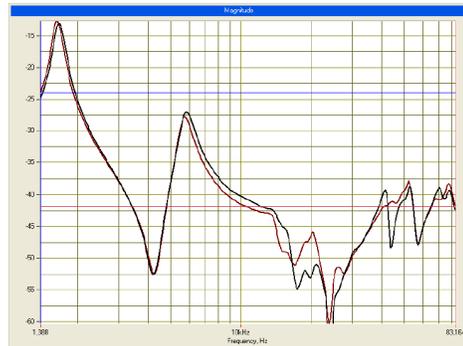
Figure-4 Graph-2: FRA scan of R Phase HV to IV winding

Suspecting the Short circuit performance of the Transformer, a set of SFRA scans were performed on the Transformer. The response was superimposed on pre-commissioning results to see if SFRA test show any abnormality. SFRA results did indeed clearly show that the R-phase Transformer winding has moved.

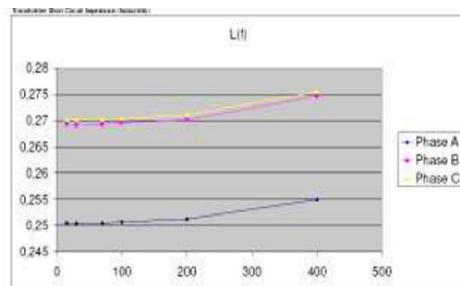
Figure 5: Short circuit Inductance plot of FRSL measurement of Common winding

- Change in the REACTANCE of Common winding (IV-N) of Autotransformer is very significant in R Phase, which is almost 10 % when compared to other two phases as indicated in Graph 4.
- Change in the REACTANCE of Full HV winding (HV-N) of Autotransformer is also significant in Phase A, which is almost 5 % when compared to other two phases.

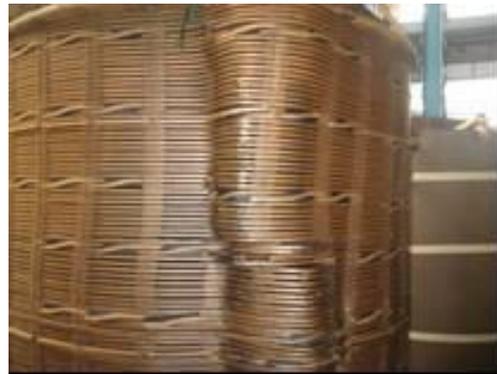
Figure-6 Damaged winding of Transformer

After carrying out all these tests, it was recommended by the manufacturer to charge the Transformer with increased DGA monitoring (fortnightly basis). The Transformer again tripped after five days on differential protection while feeding fault current in 220 kV systems. The transformer was taken out of service and sent to manufacturer's works for detailed investigation. R phase IV winding (220kV) found badly deformed as shown in the figure below:

The transformer was repaired at manufacturer's works by replacing all the coils in R phase. The transformer is operating satisfactorily.

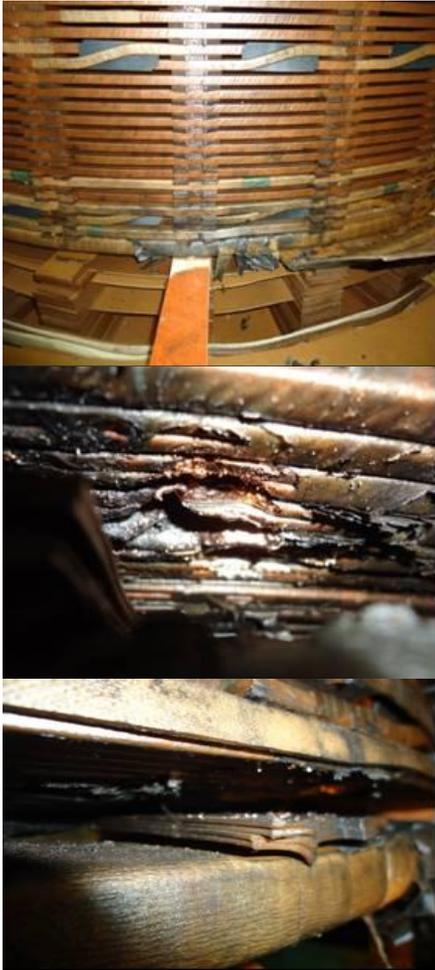
Figure-7 Failure of Winding

As internal inspection could not reveal any other abnormality, it was decided by the manufacturer to take back the transformer to their works for detailed investigation and rectification. During investigation it was found that in IV winding, out of 8 conductors, the extreme conductor was open. The fault was located at the bottom and probably due to manufacturing defect. As the burning was inside and there was no oil circulation in that spot, DGA has not indicated appreciable increase in fault

Copper globules were found and burning marks also noticed on conductors of first disc from bottom and two bays towards the left of IV bottom lead. Flash over mark was also observed on bottom SER (Static End Ring).
